# **Assessment of Dam Safety of Coal Combustion Surface Impoundments**

**Indianapolis Power & Light Company**

**Eagle Valley Generating Station**

**November 15, 2010**

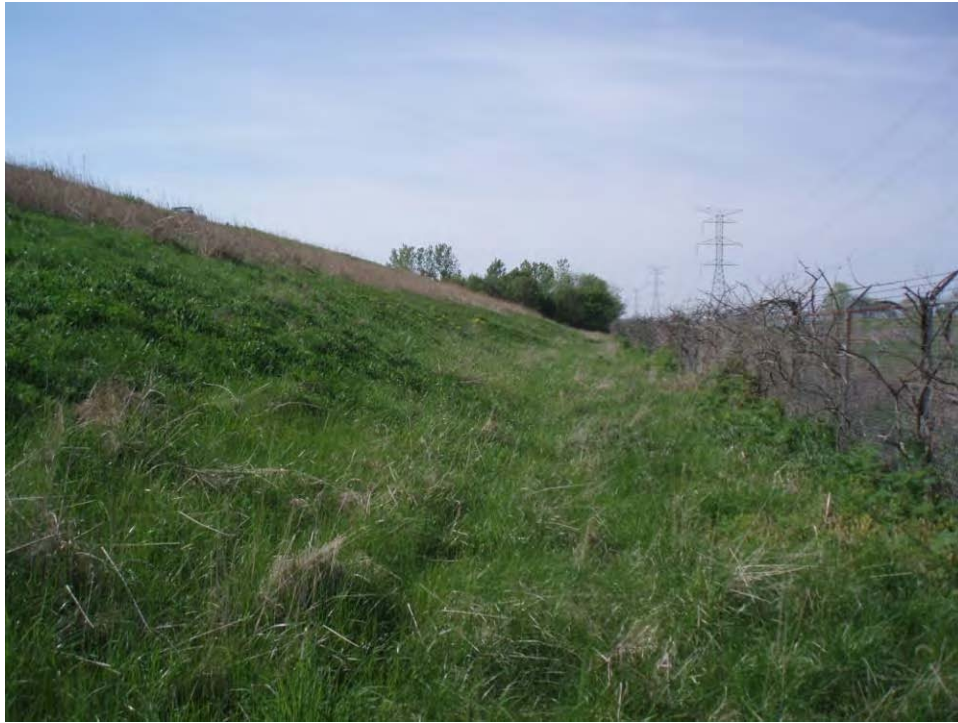
91. Pond D – West embankment exterior slope, looking south.

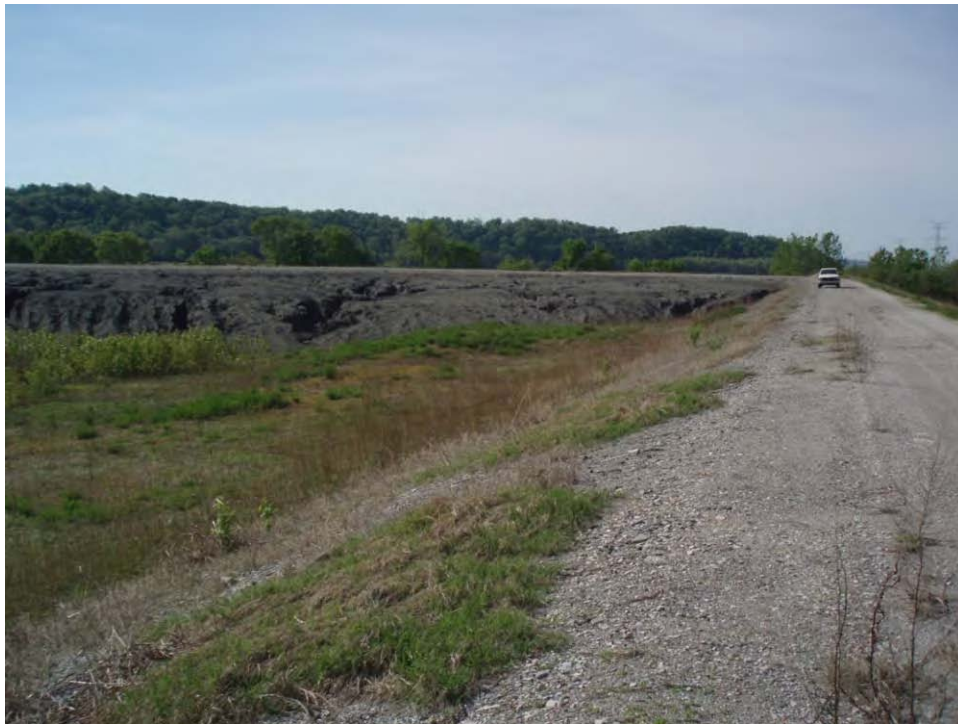
92. Pond D – West embankment interior slope, looking south at edge of ash limit prior to Pond D/E embankment failure.

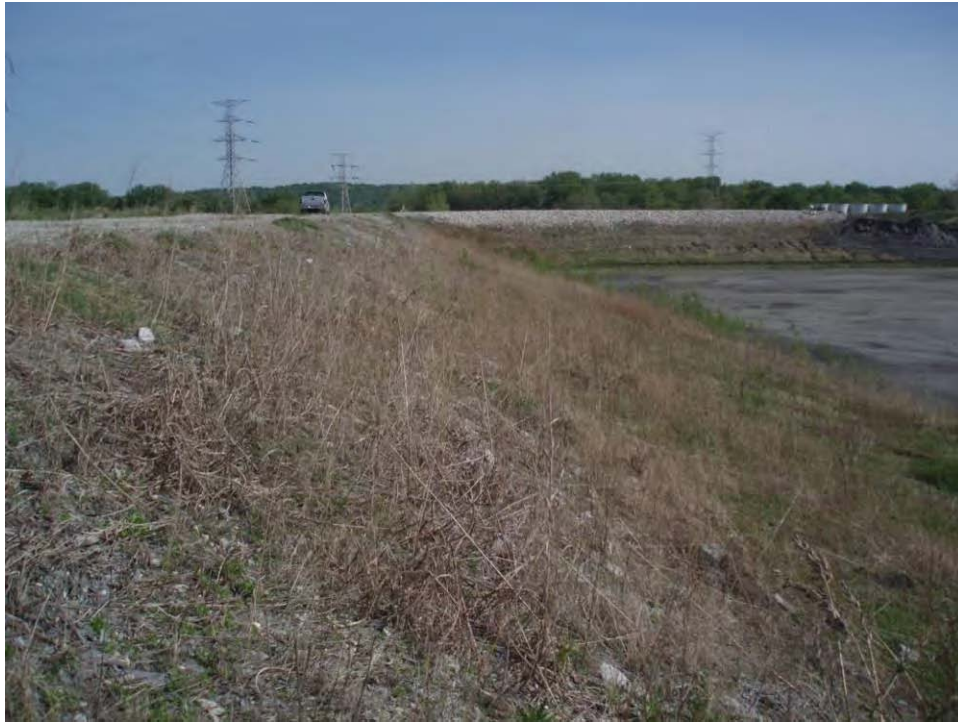
93. Pond D – West embankment interior slope, looking north toward divider embankment D/E.

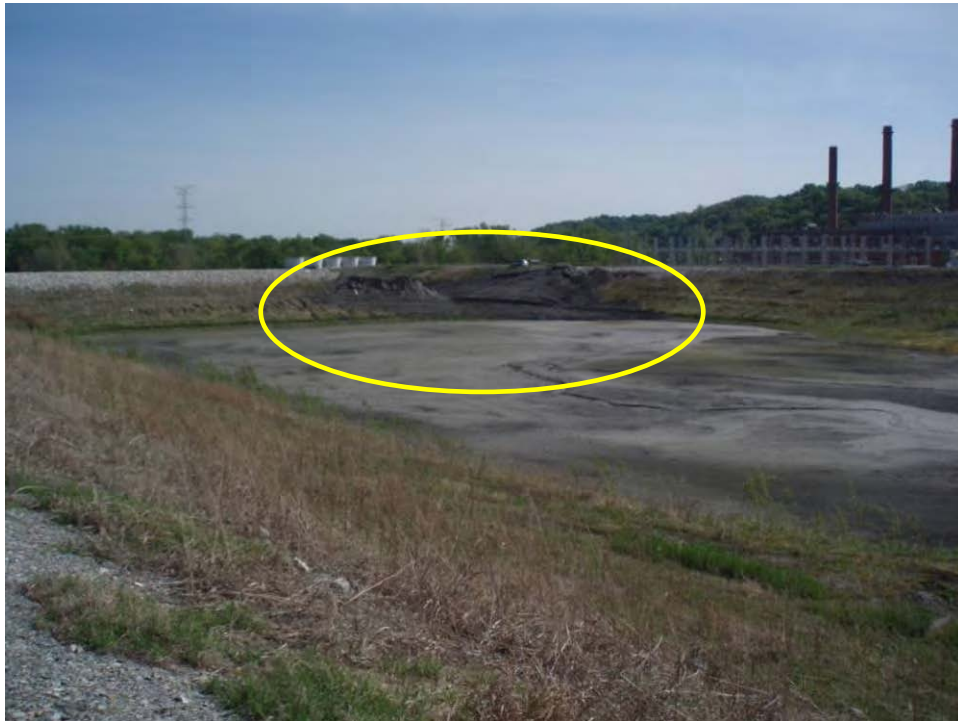
94. Overview of Pond D, south slope of divider embankment D/E, and west slope of Pond D divider embankment. Note breach (circled) in divider embankment D/E.

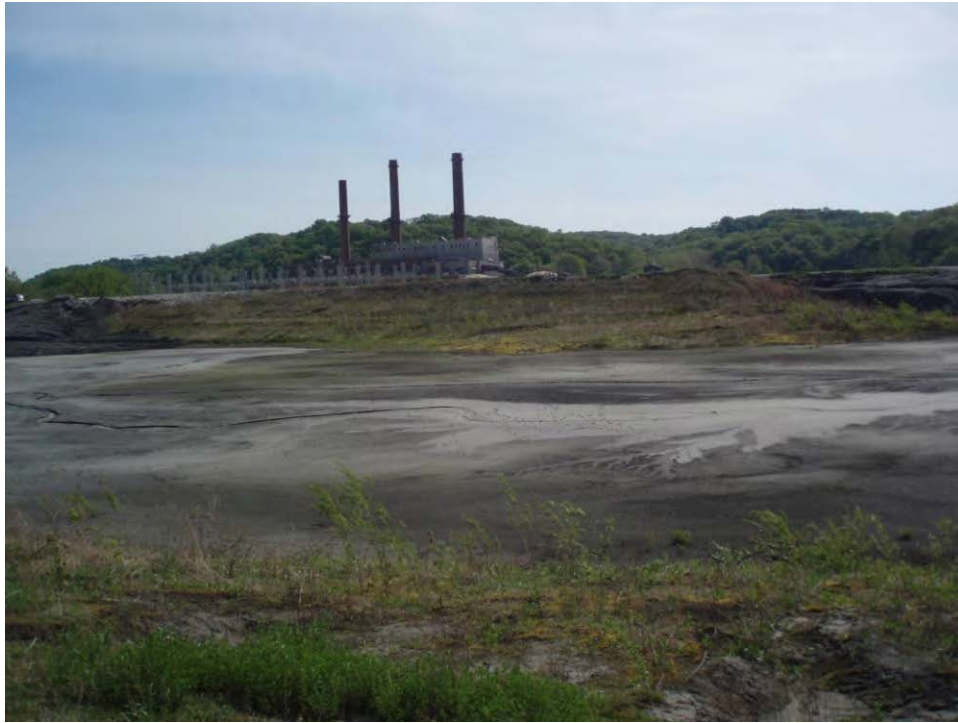
95. Overview of Pond D and west slope of Pond D divider embankment, looking east.

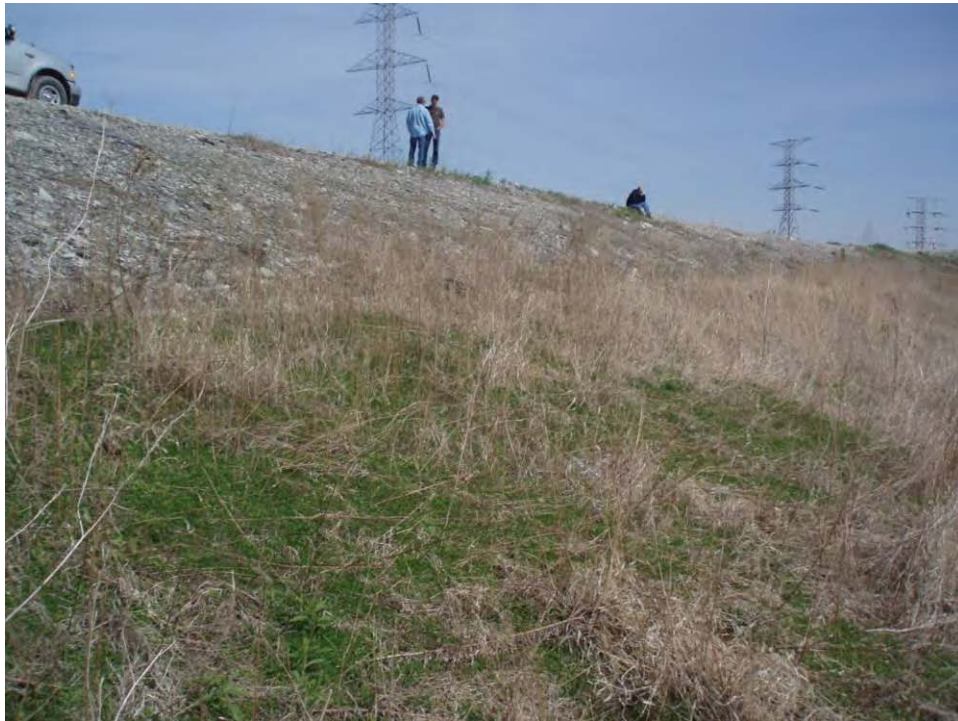
96. Pond D - West embankment typical interior slope with shale armor near crest.

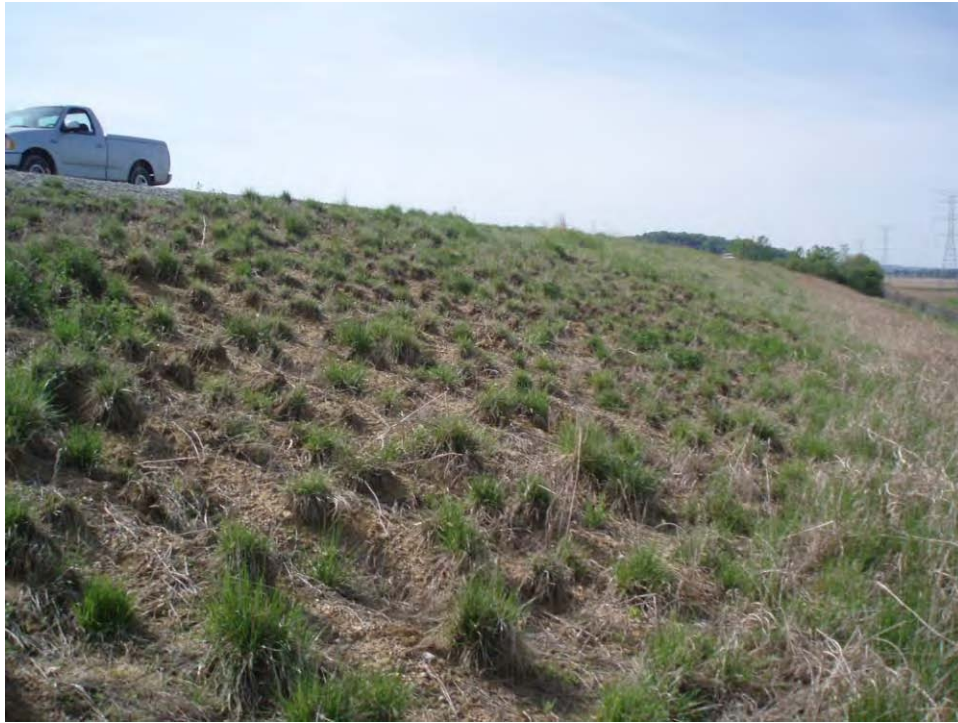
97. Pond D – Typical bare spot and erosion on west embankment exterior slope, looking southeast.

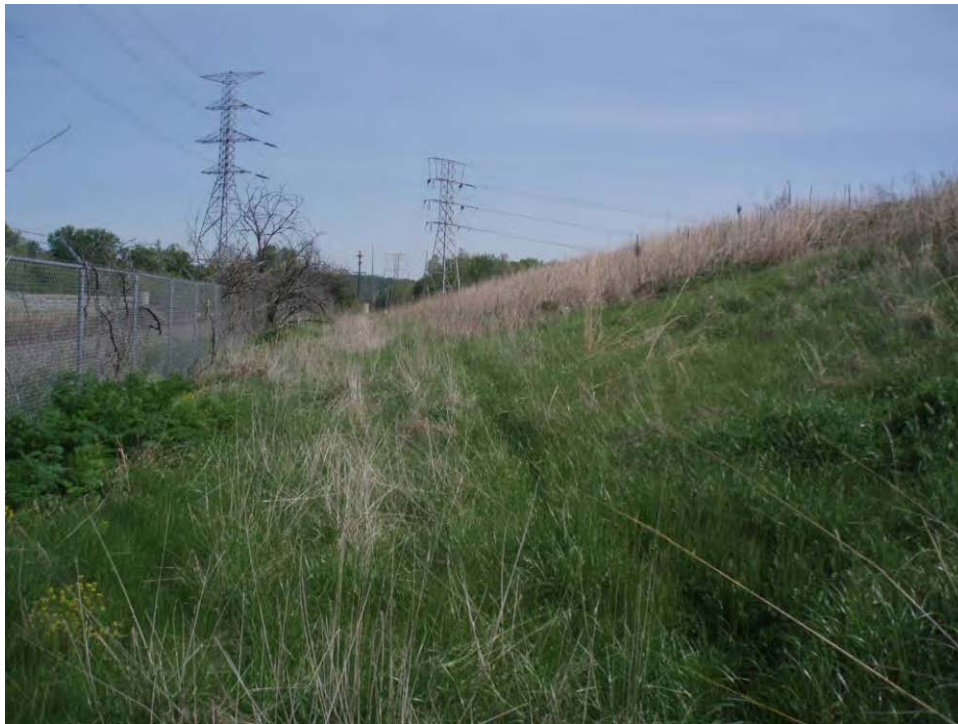
98. Pond D – West embankment exterior slope at toe, looking north.

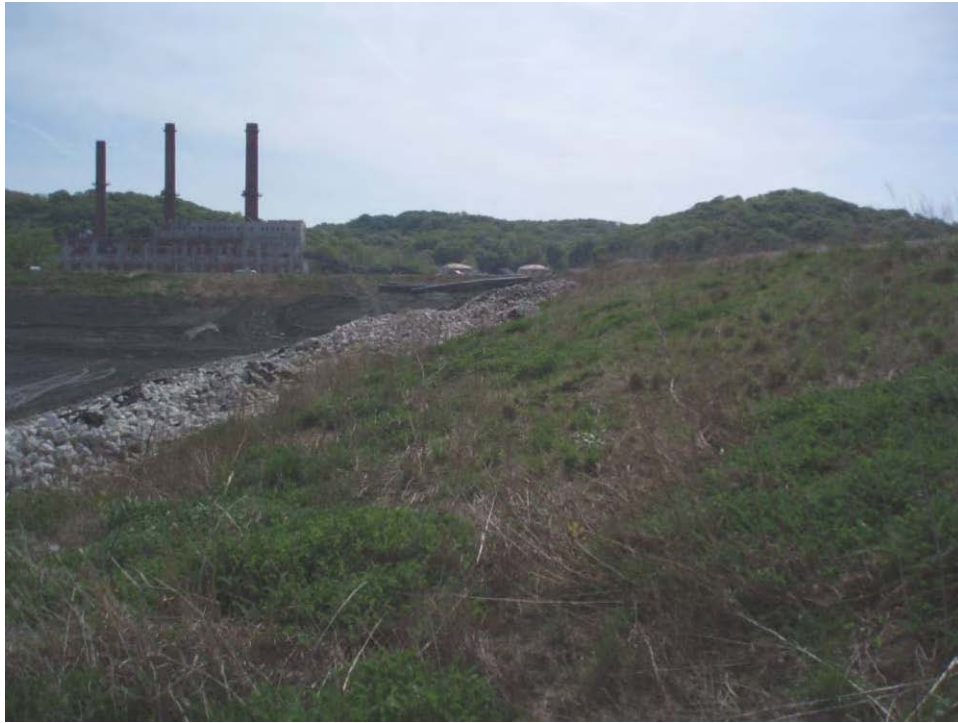
99. North slope of divider embankment D/E, looking east.

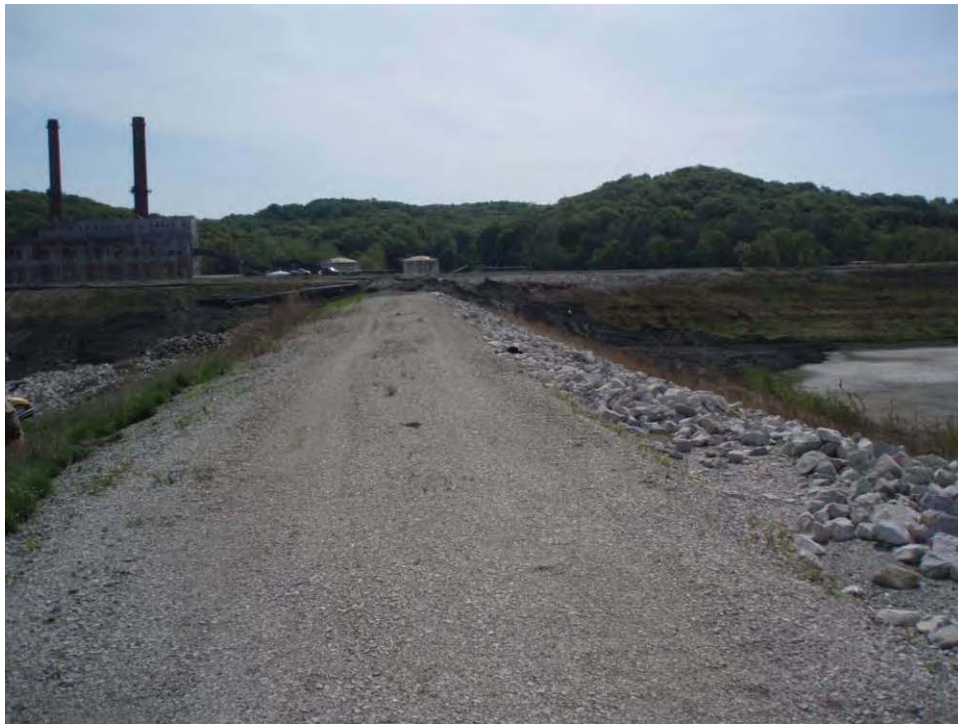
100. Crest of divider embankment D/E, looking east.

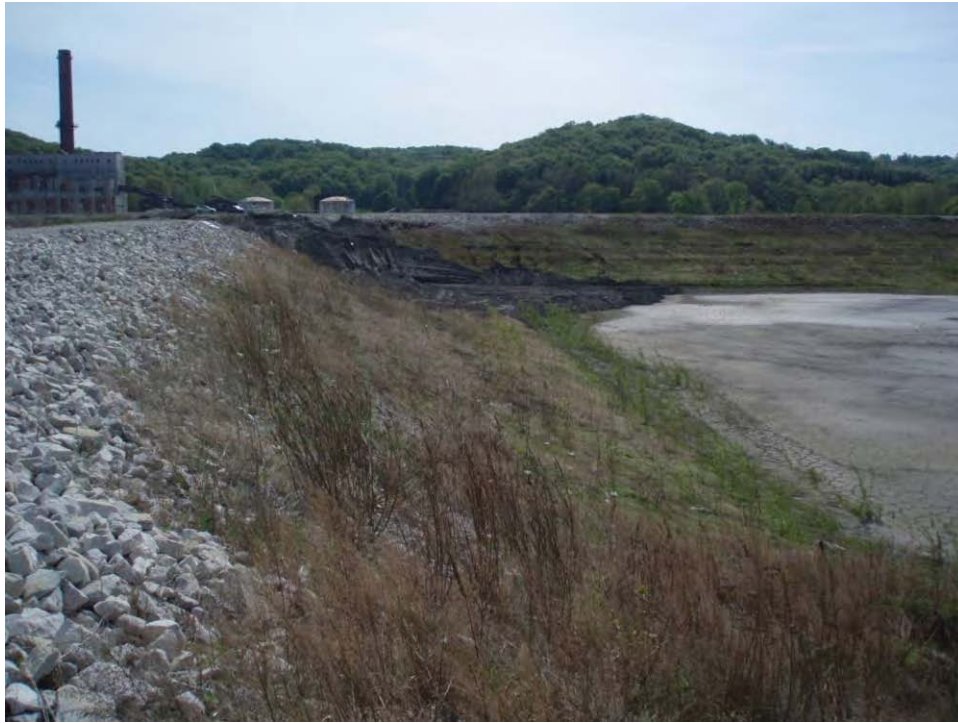
101. South slope of divider embankment D/E, looking east.

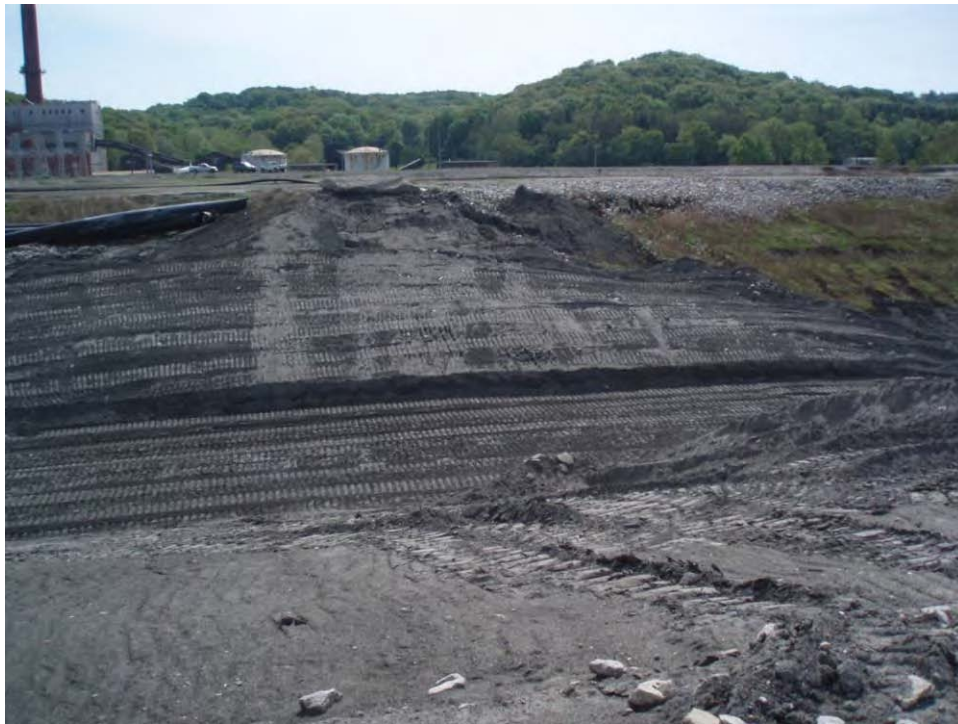
102. Overview of cut in divider embankment D/E for repair work.

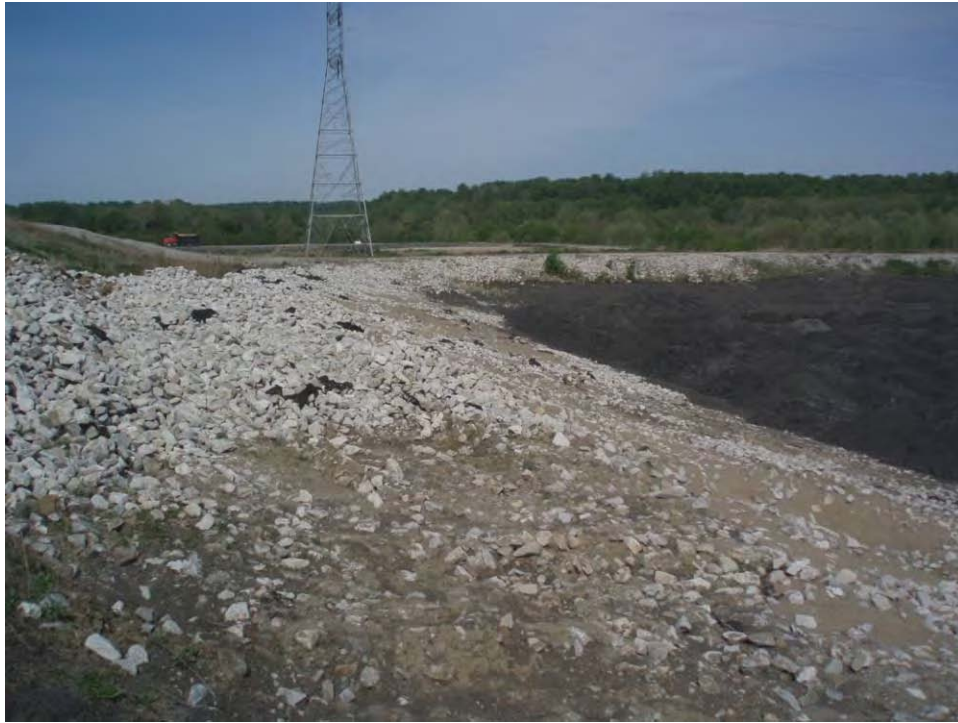
103. North slope of divider embankment D/E, looking west.

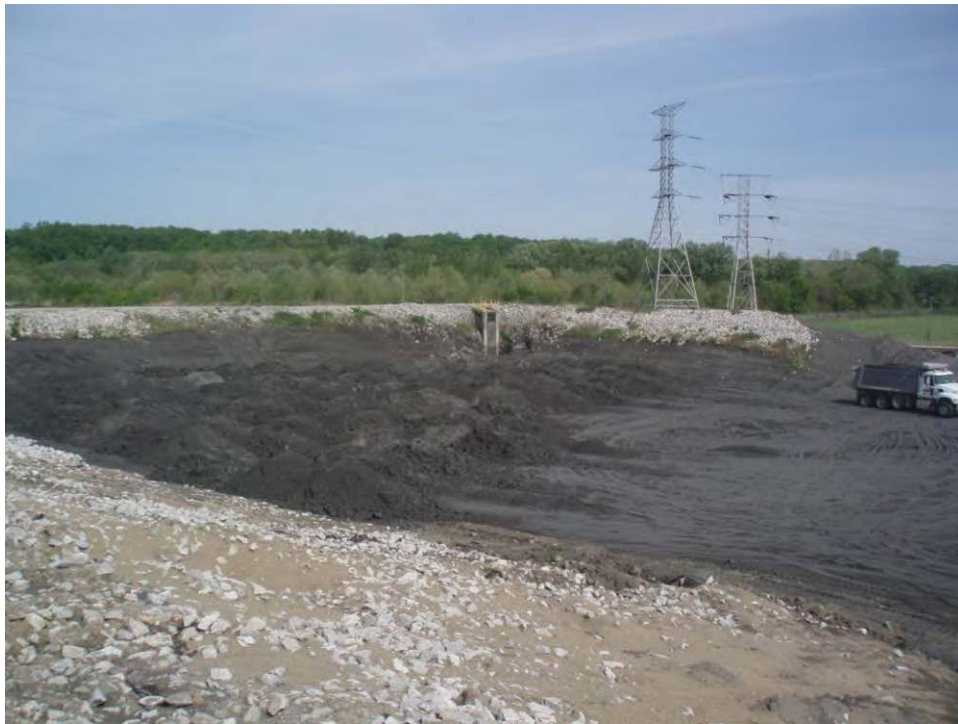
104. Overview of Pond E backfilling operation and Pond E outlet structure, looking northwest.

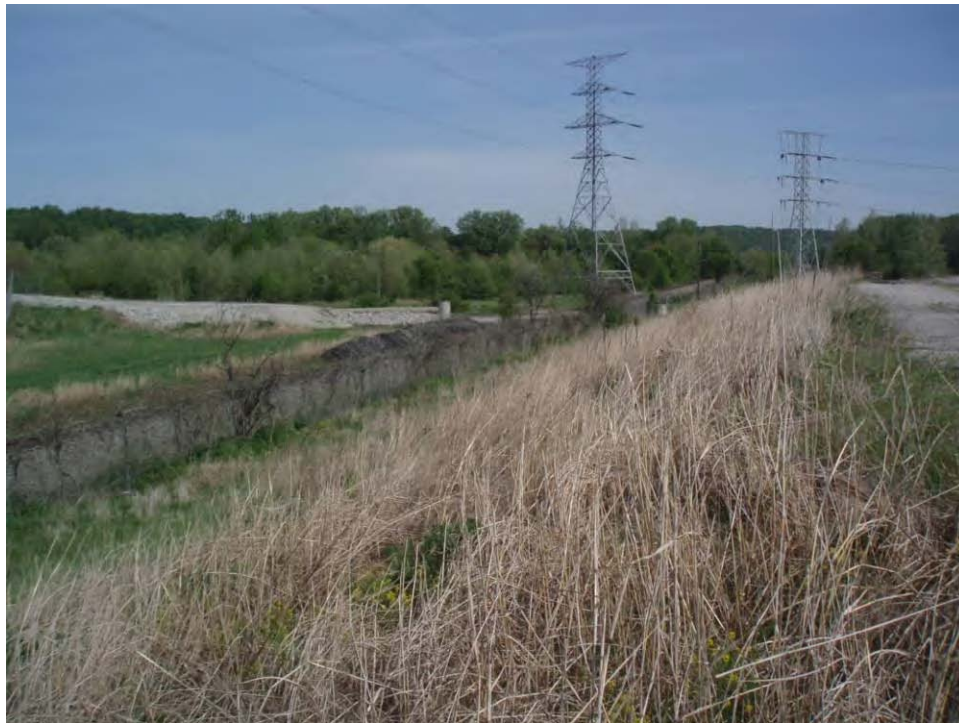
105. Pond E - West embankment exterior slope, looking north.

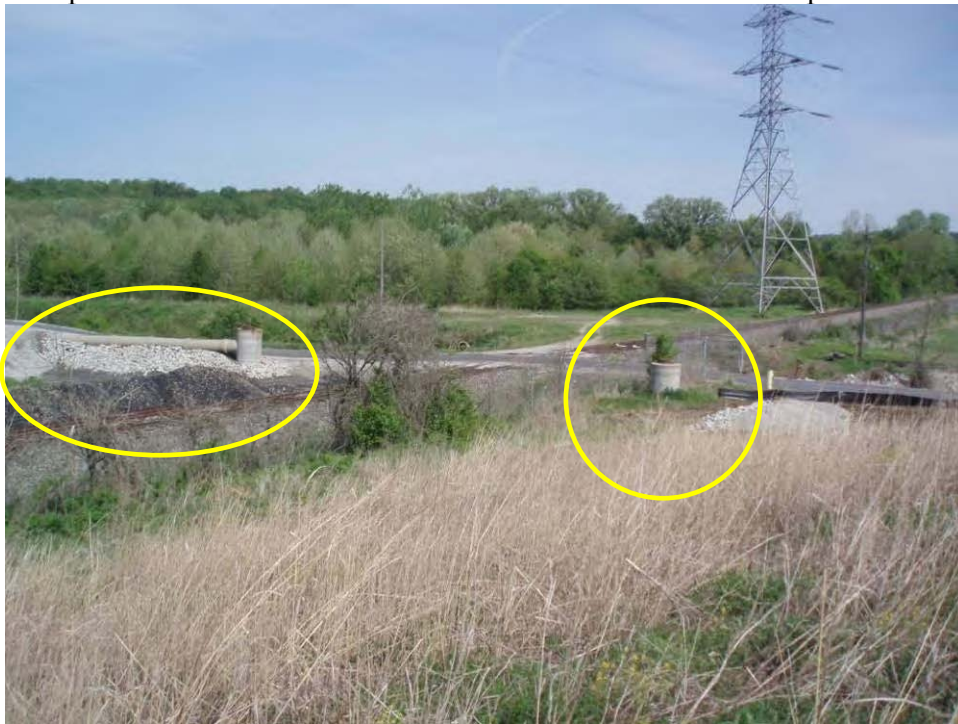
108. Overview of discharge manholes from Pond E into Pond C, looking northwest.

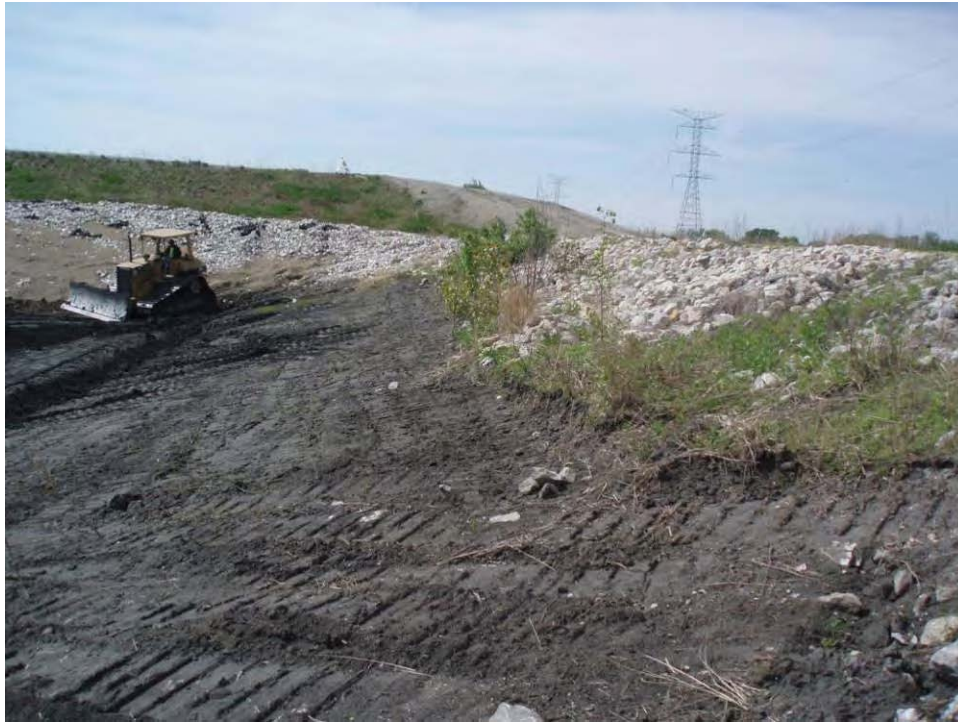
109. Pond E - West embankment interior slope, looking south.

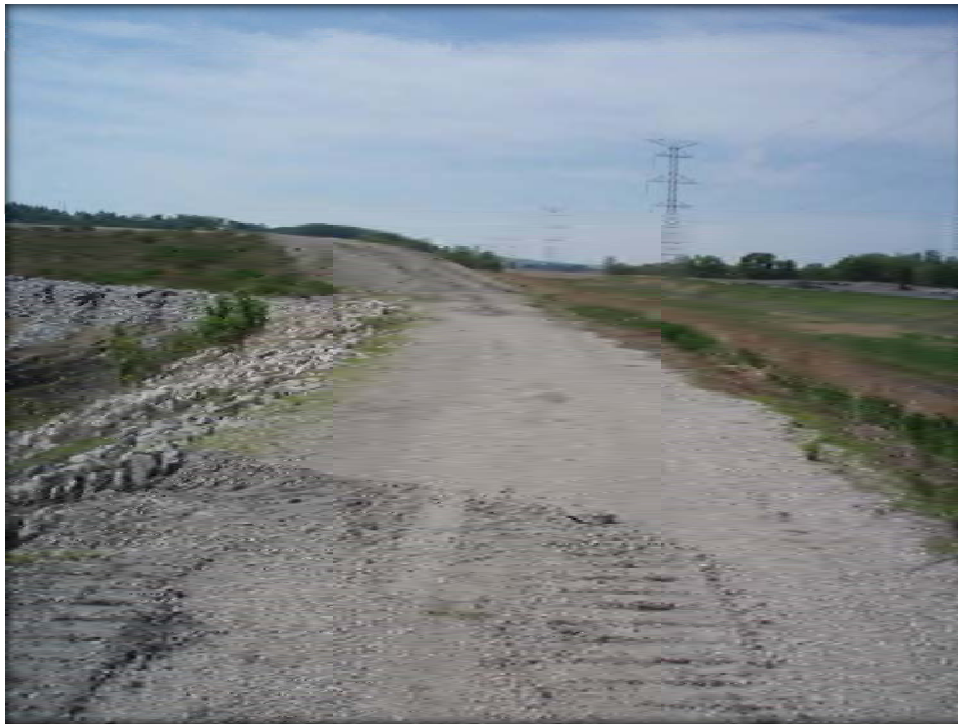
110. Pond E - West embankment crest, looking south.

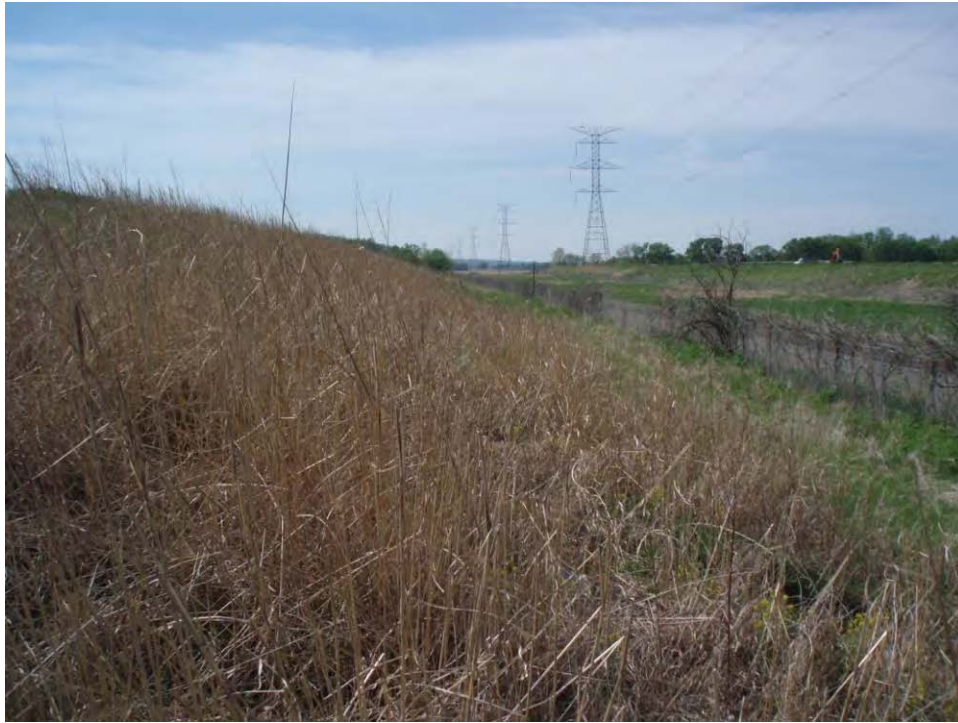
111. Pond E – West embankment exterior slope, looking south.

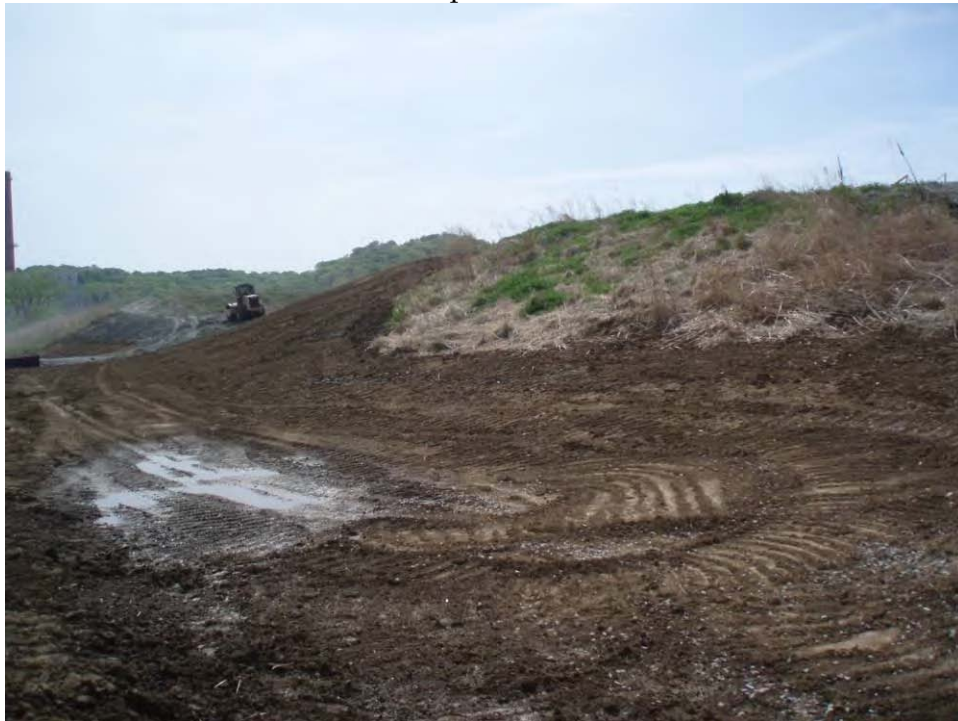
114. Pond E – Downstream area looking south toward failure repair (reconstruction of north embankment).

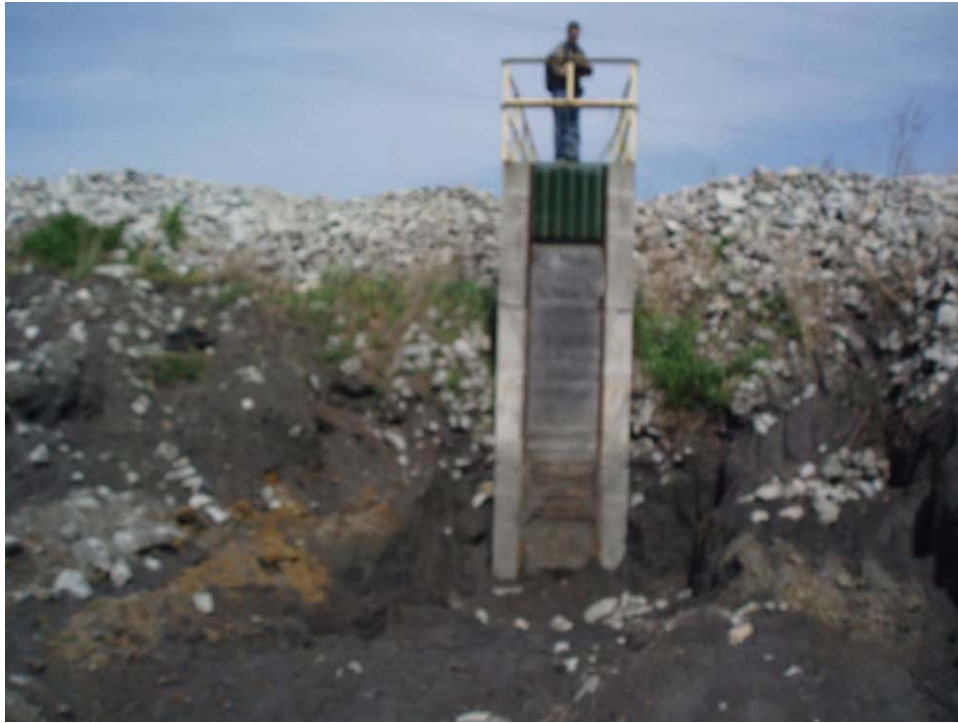
115. Pond E – Overview of outlet control structure with stoplogs and butterfly valve, looking northwest.

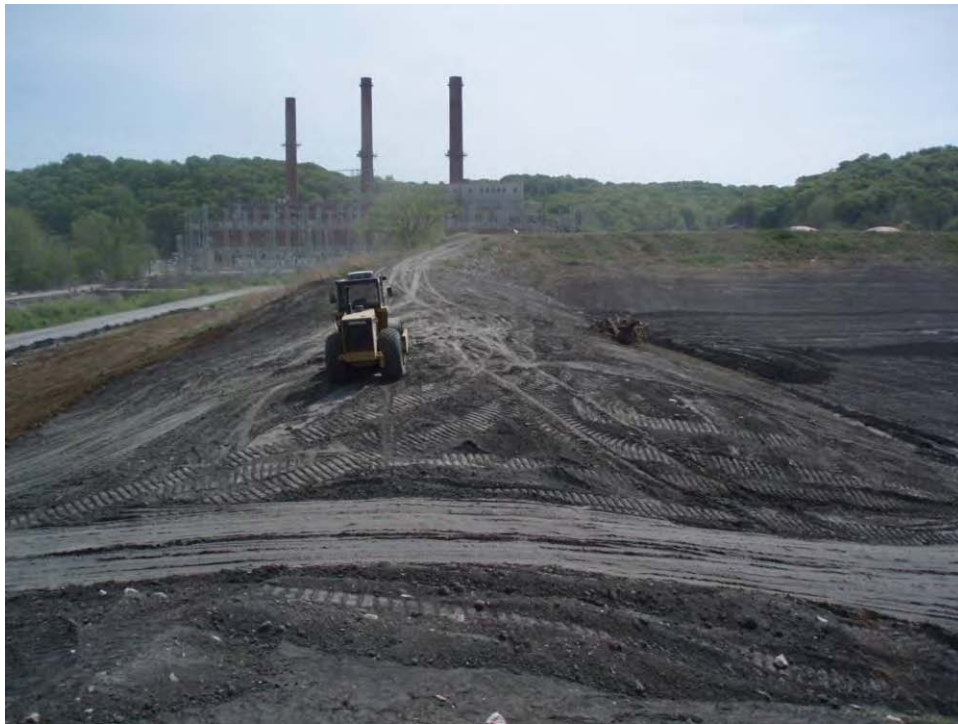
116. Pond E – Overview of north embankment reconstruction, looking east.

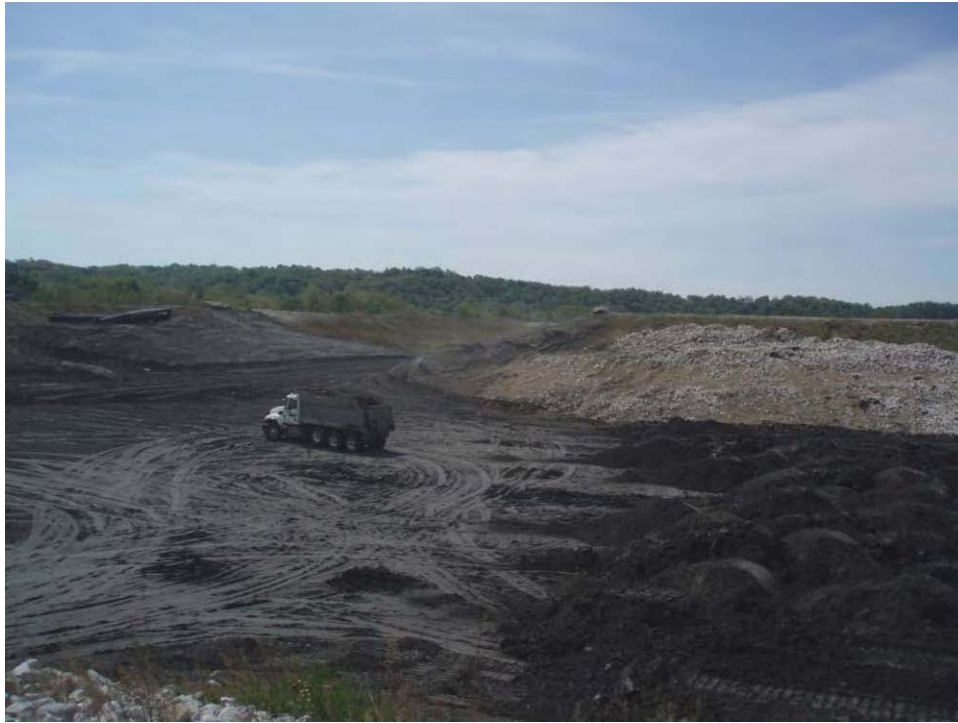
117. Overview of divider embankment D/E reconstruction and Pond E filling operation, looking south.

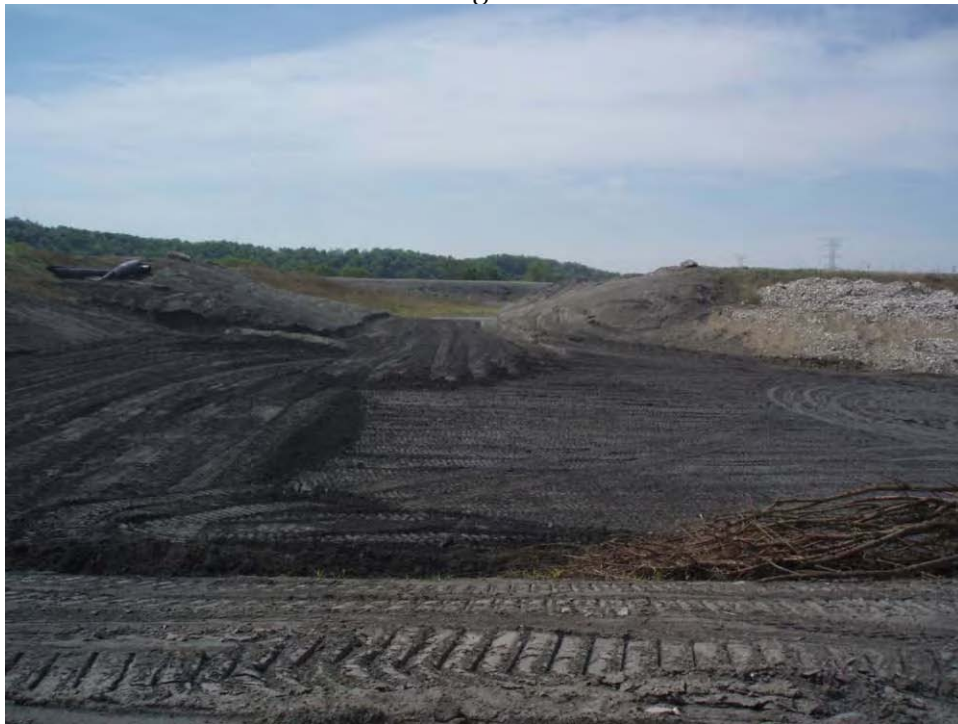
118. Overview of divider embankment D/E reconstruction, looking south.

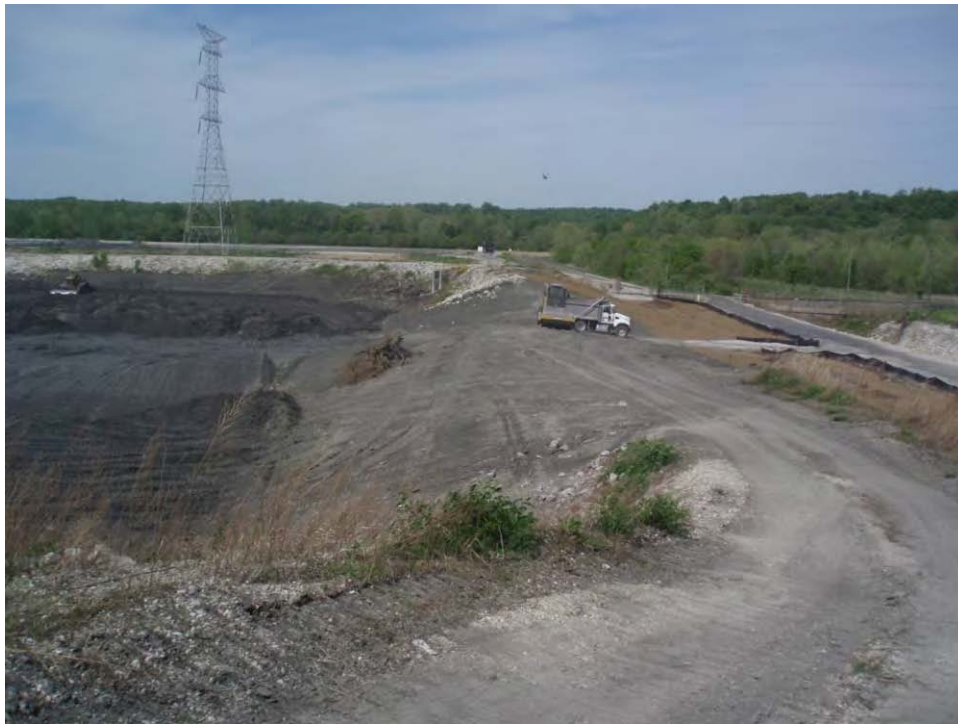
120. Pond E – Overview of north embankment reconstruction, looking west.

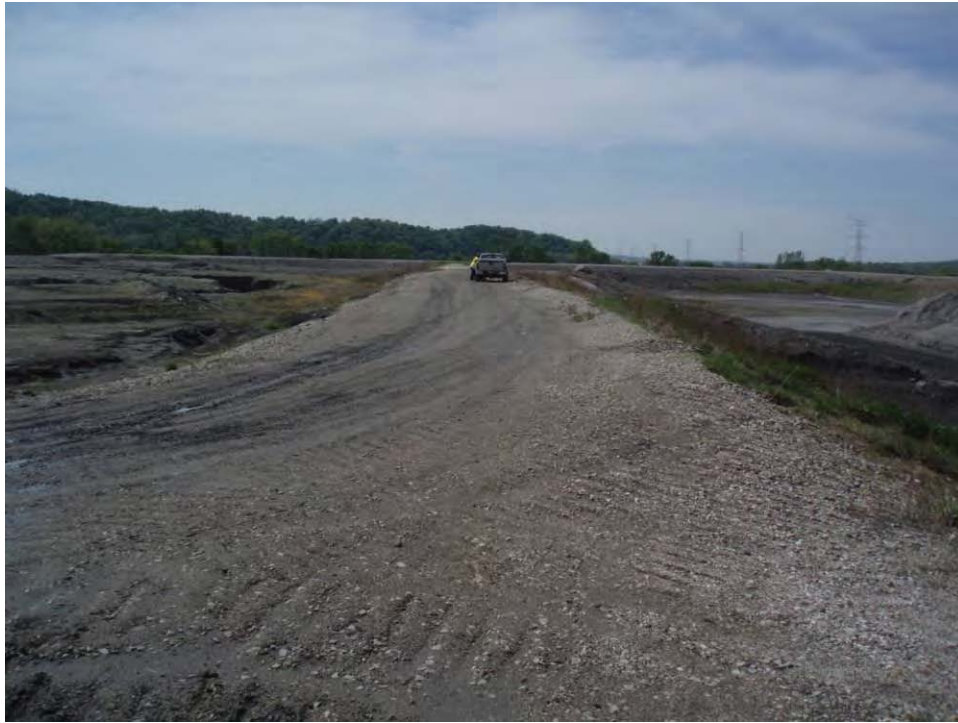
121. Crest of divider embankment D/E, looking south.

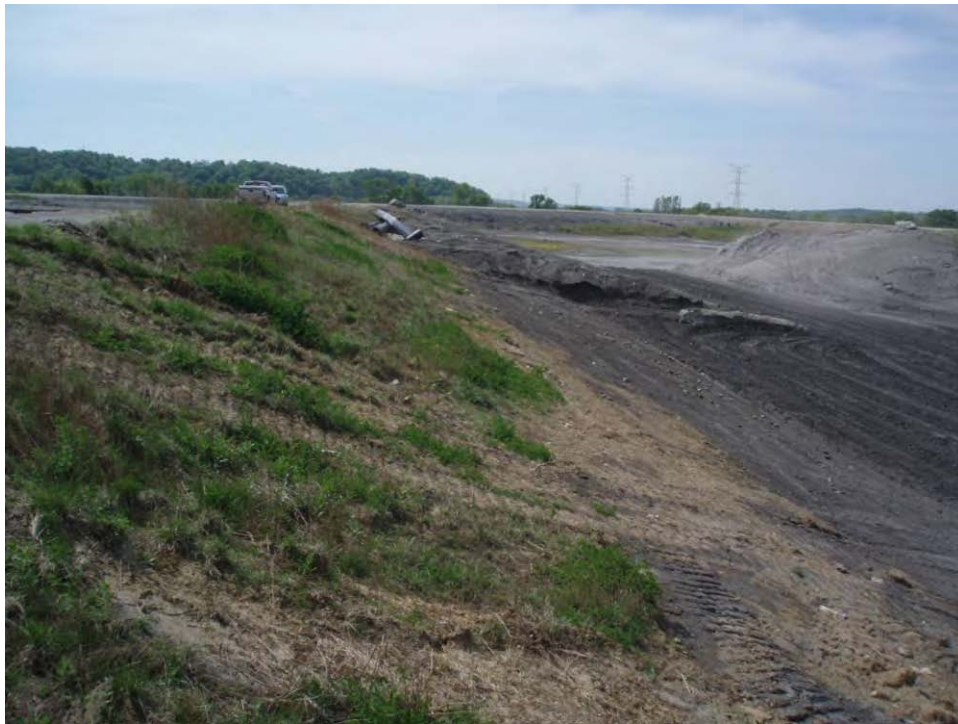
122. West slope of divider embankment D/E, looking south.

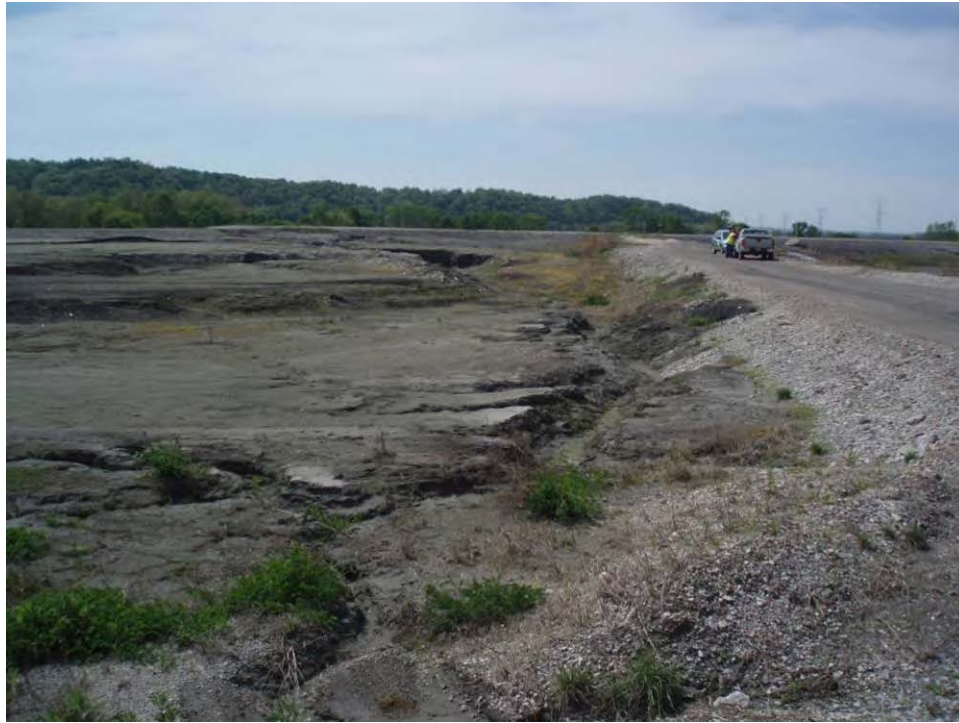
123. East slope of divider embankment D/E, looking south.

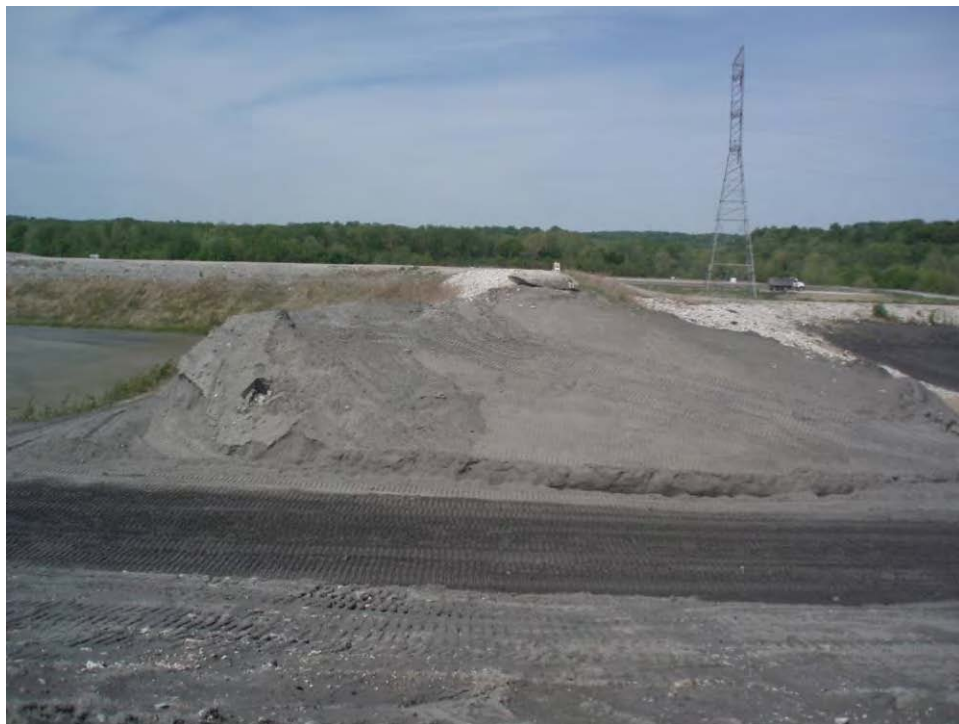
124. Overview of divider embankment D/E reconstruction, looking west.

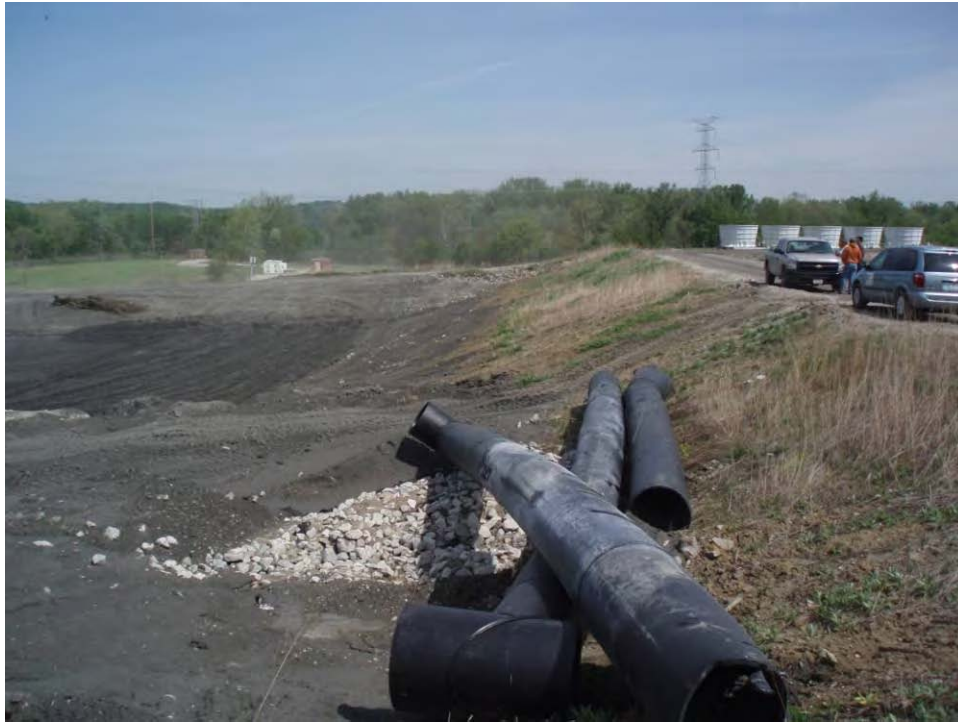
125. West slope of divider embankment D/E, looking north. Note pipes removed from embankment after breach.

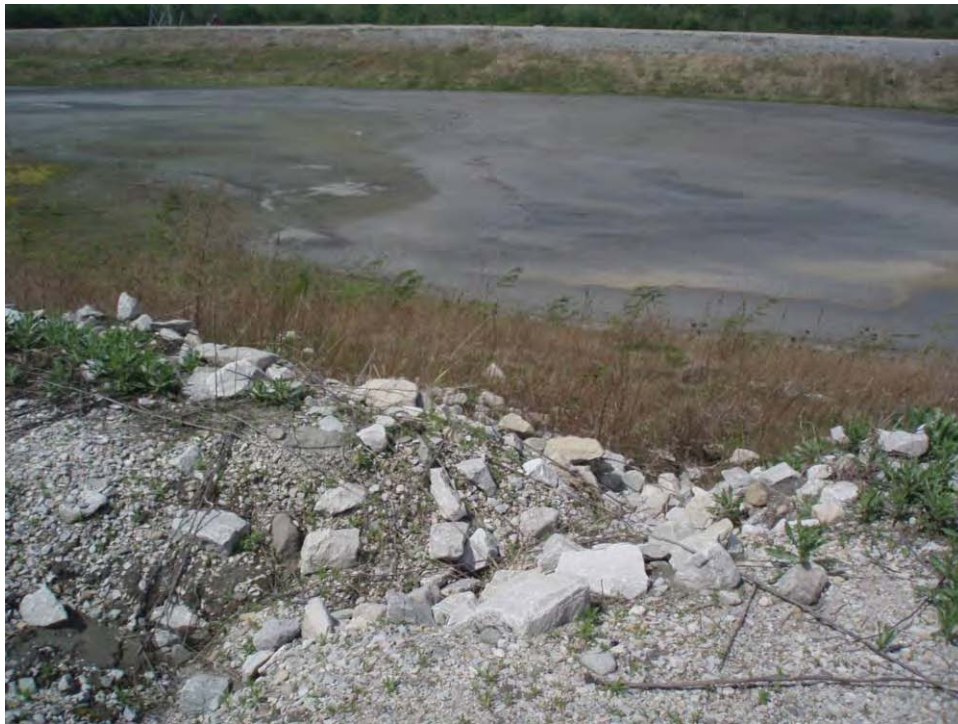
126. Pond D - Erosion rill on west slope of divider embankment, looking southwest.

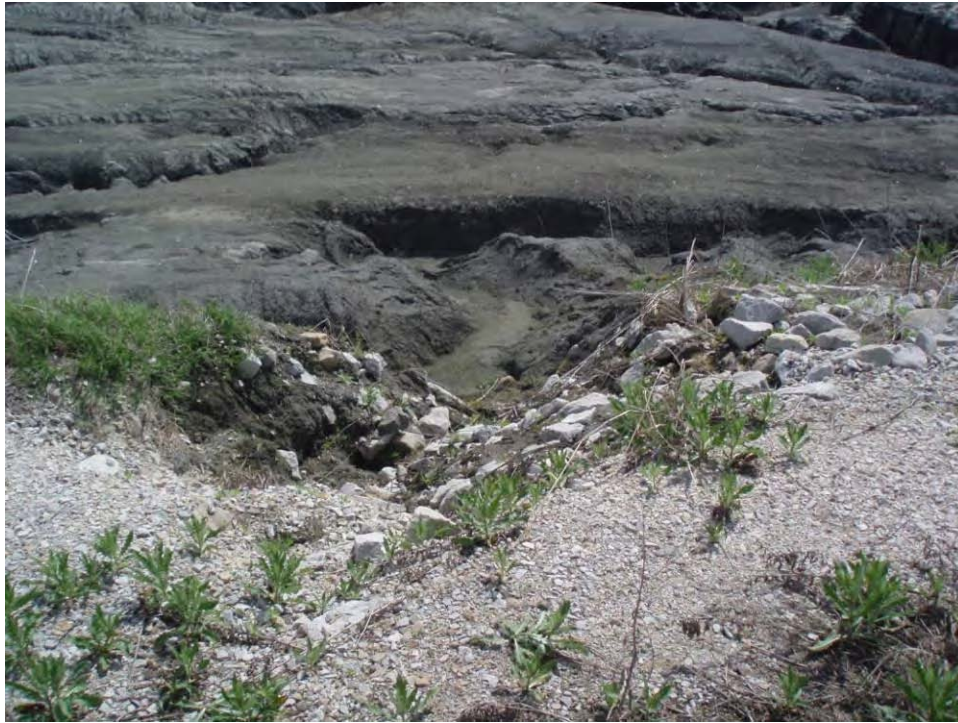
127. Pond D - Erosion feature on east slope of divider embankment, looking east.
